Structural durability

In theory and practice

White Paper

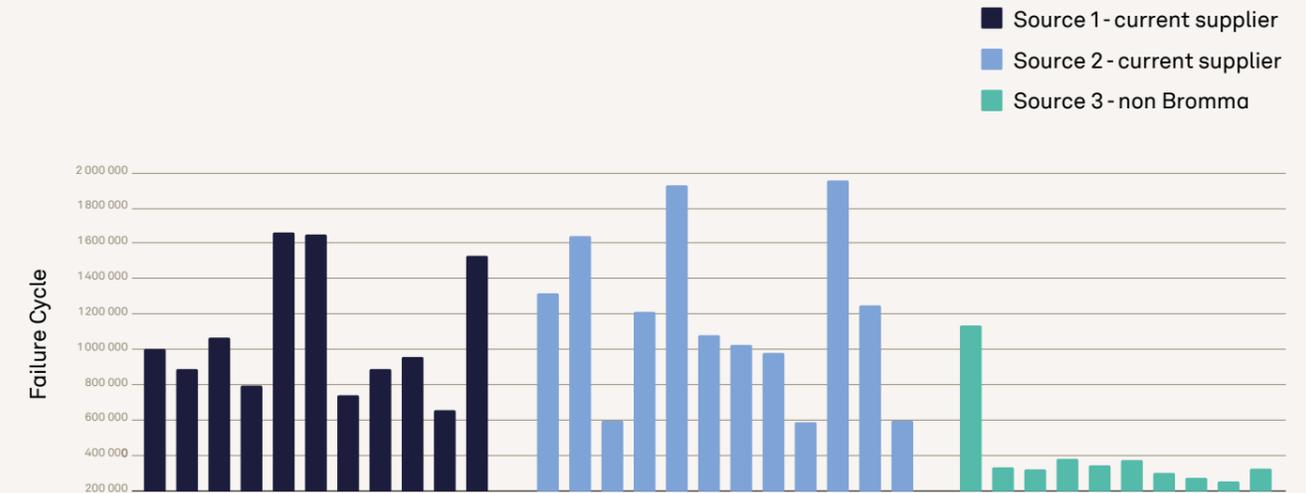
Bromma is using test jigs to verify the theoretical calculations made and to evaluate the genuine spare parts we are supplying against alternatives available on the market. The jigs used can test and evaluate up to 30 individual twistlock pins at the same time.

The test jig was configured for a long-term test where a load amplitude of 25 MT was cyclically applied until each individual twistlock pin failed through breakage.

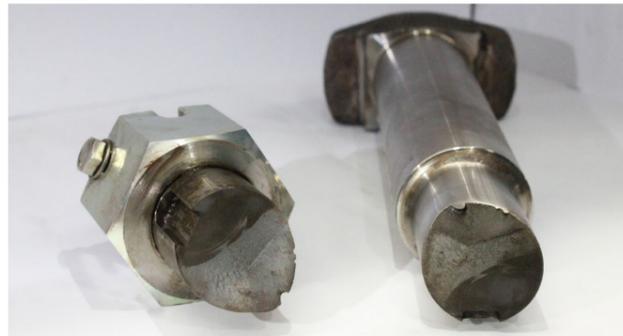
The graph above shows the results from the tests performed. Bromma twistlock pins from two different sub-suppliers are tested together with a third party “Bromma copy” available on the market. The results are stunning! The height of the bars indicates when the twistlock pins broke as a result of fatigue. It should be noted that the load applied in these tests are significantly higher than what is seen in real operations but the test shows the relative difference in durability between the original and a copy. The average Bromma twistlock pin outperforms the non-original by more than four times.

Source	No. of samples	Median failure	Mean failure
#1	11	753 469	872 176
#2	12	945 185	979 762
#3	10	127 832	202 601

The results from this study show that the number of cycles exceeds – despite a higher load than normal - the recommended replacement cycle by far. This is a safety margin that is built into such a critical component to withstand the harsh conditions typically experienced by a spreader. It is the safety margin that comes with Bromma genuine spare parts.
